Beauty Creek Watershed Study April, 2016

City of Valparaiso, Porter County, Indiana

DLZ Job No. 1564 -1276
April, 2016

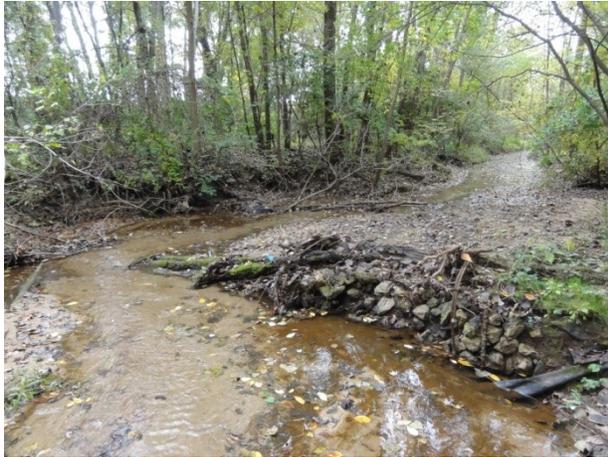
Evidence of other stabilizing practices was observed, including what appeared to have been a Gabion dam and a wooden cross vane structure (photos BC 49 and BC 56). A cross-vane structure forms a "V" in the channel with a wide bottom in the "V" approximately the width of the channel. Both structures appeared to have degraded with the Gabion dam having failed such that the stream has migrated around the dam toward the north bank.

BC49-Failed Man-Made Dam

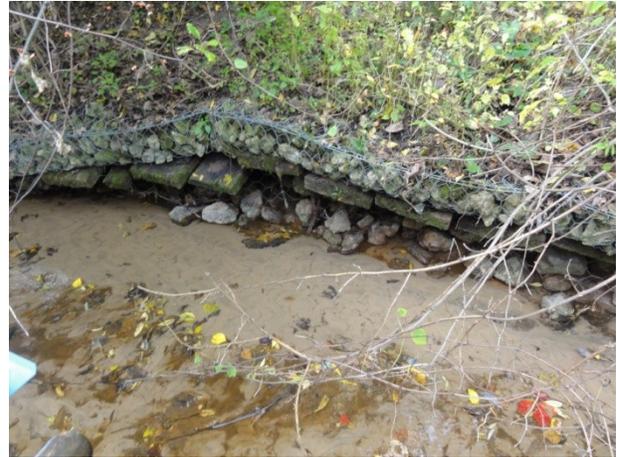
Various stabilization structures appear to have been constructed previously in the stream around St. Paul's. Gabion baskets (galvanized wire baskets filled with stone) and Reno blankets (galvanized wire blanket filled with stone) appeared to have been installed on the banks around the outside bends. Documentation provided by the City indicates these are around 20 years old. The blankets on the upper bank areas appeared to be in good shape and performing as intended. However, in the lower bank areas the galvanized wire appeared to be deteriorating and undermining of the basket and blankets was observed (see photo BC 54).

BC54-West Bank-Stone Wall Sliding

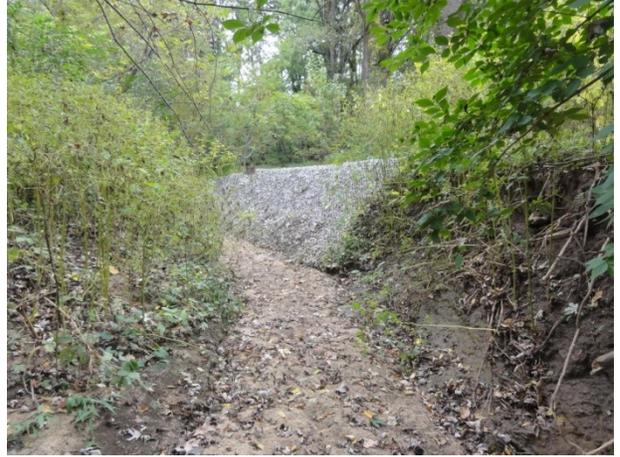
There was an area where the bank had been stabilized with Reno mattresses (see photo BC 123 and BC 125). The photos show while the bank covered by the mattresses may be more stable than adjoining banks areas, the stream bottom is being eroded as well as the upstream lower corner of one blanket. The streambed undercutting may eventually undercut the base of the blanket and lead to possible failure. In addition, the upstream unprotected bank is eroding which may also cut behind the mattress and lead to failure.

BC123-Reno Mattress on East Bank

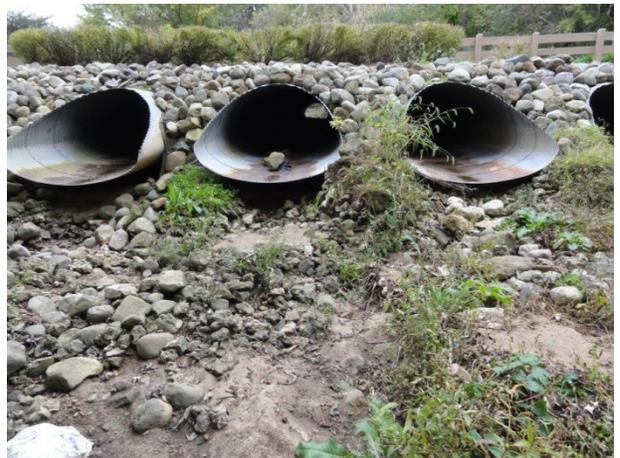
Scour at culvert outlets was observed at William Drive (see photo BC 131) and especially at the culvert under Ransom Road (see photo BC 245). While the scour was only 1-2 feet at William Drive the scour from the seven (7) foot culvert under Ransom Road was over 6 feet deep and approximately 25 wide and 30 feet long.

BC131 - William Drive Culvert Erosion

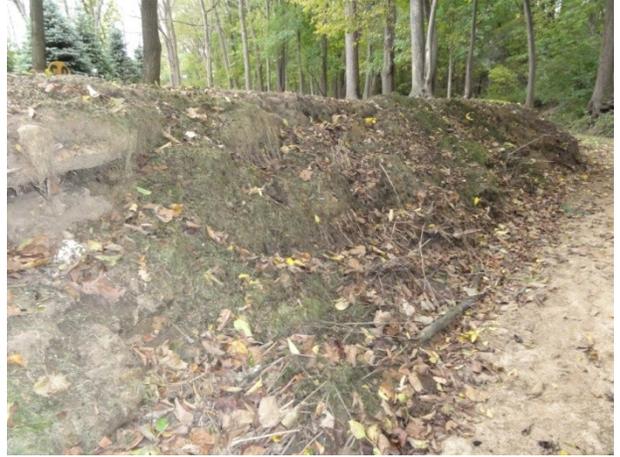
Debris apparently placed in the stream by property owners was also observed. Old fencing (see photo BC 223), grass clippings (photo BC 163) and brush were found. Photos BC 228 and BC 229 illustrate one the worst situations. While property owners may consider this a good use of the undesirable material, covering the bank can kill live vegetation and eventually be washed downstream contributing to blockages and enhanced erosion or reduce water quality by adding undesirable nutrients from decay byproducts.

BC163-Limbs Dumped on Bank

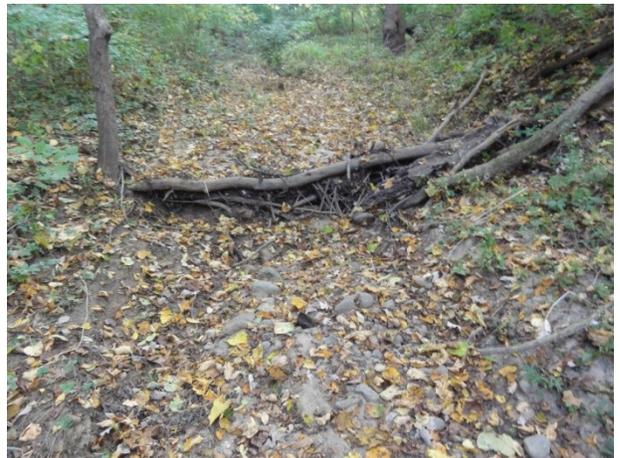
The upper branch of Beauty Creek displayed similar erosion problems as observed in the lower branch. Blockages and bend erosion were frequently observed. Examples of the bend erosion can be seen in photos BC 121, BC 143, BC 210 and BC 222. Examples of bend blockages including log jams were noted throughout the stream course covered by this study (see photos BC 139, BC 158, BC 165 through 179, and BC 236). Besides diverting flow into the bank, debris can also create scour holes by creating a hydraulic jump (see photo BC 189 and BC 202).

BC202-Looking North at Scour Hole

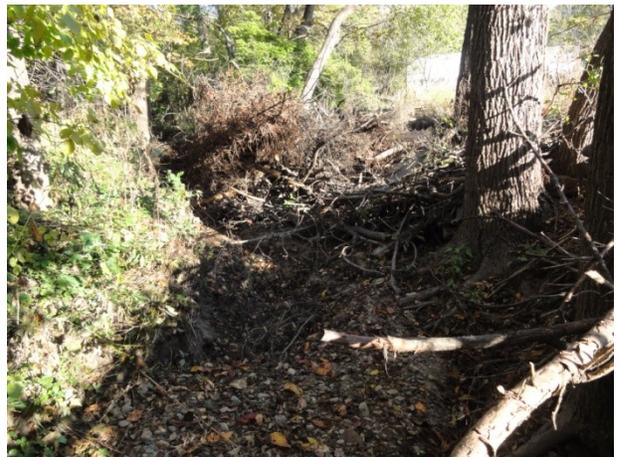
BC228-Tree Blockage with Scour Hole

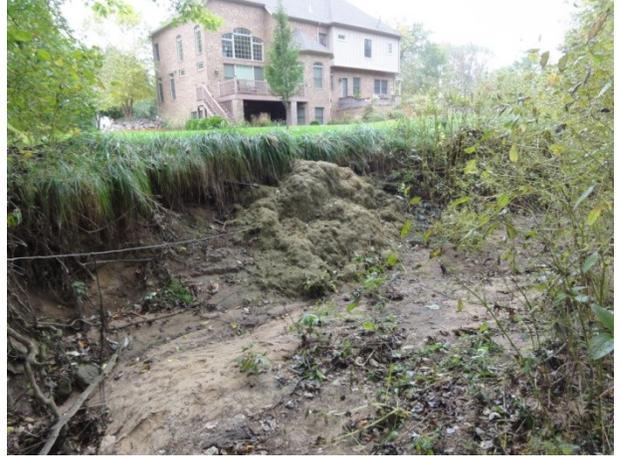
As observed on Beauty Creek, streambed and bend erosion were the primary concerns especially downstream of Hampstead Court (see photo CW 86). Some residential structures are located close to the streambed (see photo CW 77 and CW 83, CW 90) and the erosion has exposed buried irrigation piping and wire (see photos CW 79 and CW 91).

Similar to Beauty Creek, the soil above sandy strata has been eroded (see photo CW 74 and CW 78). Bend erosion is also prevalent (see photos CW 85 and CW 91) and is undermining trees. Some armoring was observed (photo CW 87) using very large stone. Disposal of grass clipping on the bank was also noted (photo CW 79).

CW79-Grass Clippings

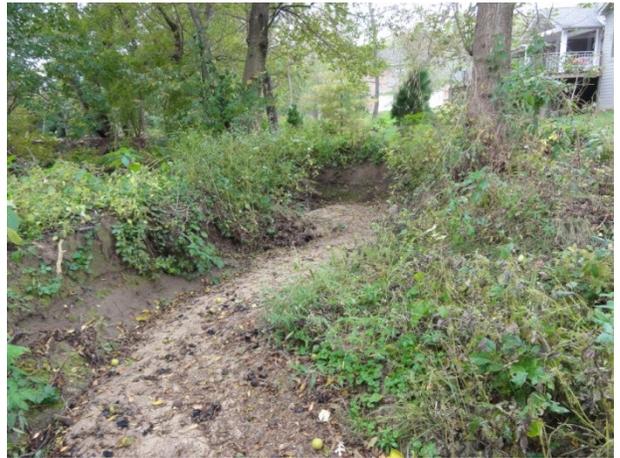
CW86-Erosion At Bend

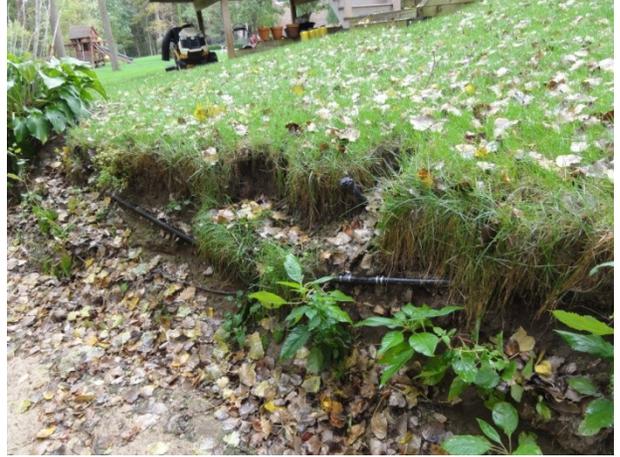
CW91-Sprinkler Pipes And Head

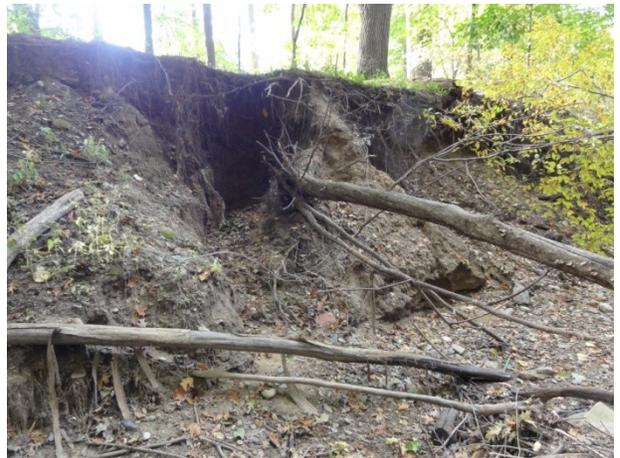
Downstream of the school property line, bank erosion, tree undermining and bank sloughing were observed (photos OW 325, OW 326 and OW 333). In addition, trees and brush were noted in the streambed (photo OW 328).

OW326-Erosion-Tree Undermined

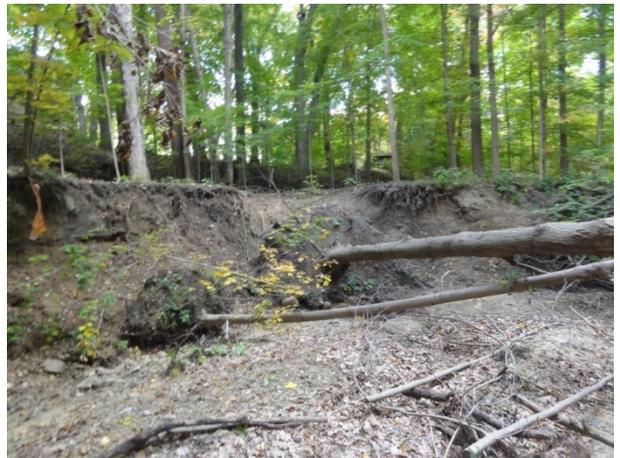
Continuing downstream, additional areas of bank erosion resulting in sloughing (photos OW 342, OW 344 and OW 345), bend erosion in sandy soil (photos OW 348 and OW 349) and debris were observed. Debris lodged in the bend of one of Old Oak Drive culverts was also observed (photo OW 390).

OW344-Downed Trees -Green Leaves

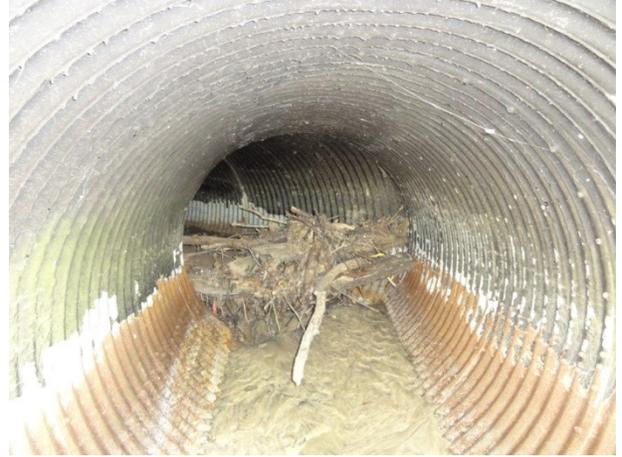
OW390- West Side of Old Oak Dr

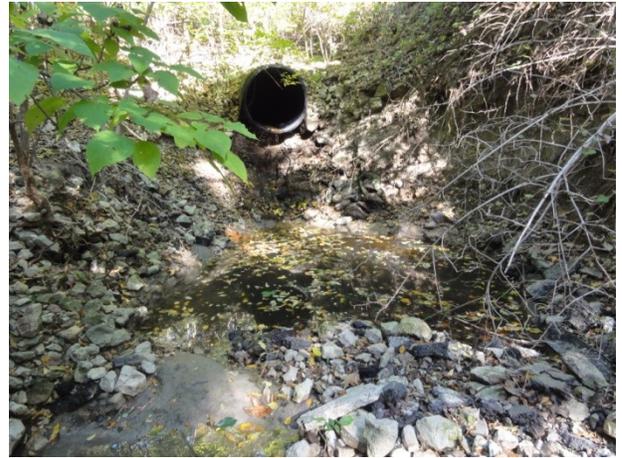
Field reconnaissance for the Forest Park branch began at the upstream end. The beginning is a 36 inch outfall pipe and scour was observed at this outfall (see photo FP400). The depth was approximately 4-5 feet. The ravine itself is relatively narrow (12 feet wide and approximately 20 feet deep) with additional pipe outfalls above the streambed (see photos FP 401, FP 402 and FP 403), all showing some degree of scour.

FP400-Two Outlets-36 Inch and 21 Inch

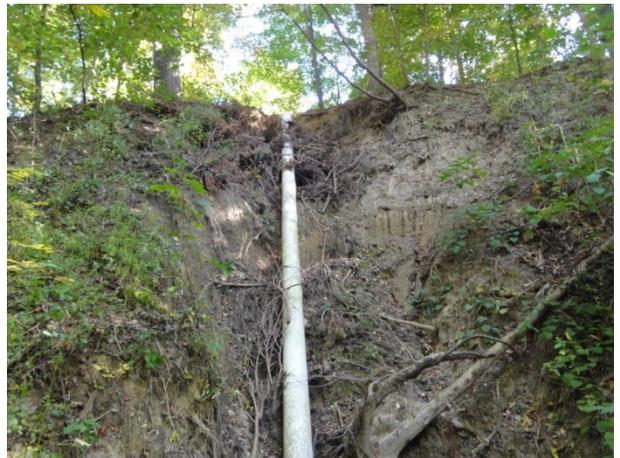
In addition to storm sewer outfall erosion, discharge from single family homes was observed to be eroding the banks and contributing to the sediment load (see photos FP 432, FP 433, FP 444 and FP 445). Outlets piped down hills and scouring the ground upon exiting the bottom of the pipe and outlet structures in need of maintenance were noted. Bank sloughing appeared to be occurring in the upper section of the branch (see photos FP 406, FP 407 and FP 426). Undermining of large trees (see photos FP 424 and FP 425) was also occurring in the upper section of the branch.

FP433-Erosion From Rear Yard Pipe-Same
FP432

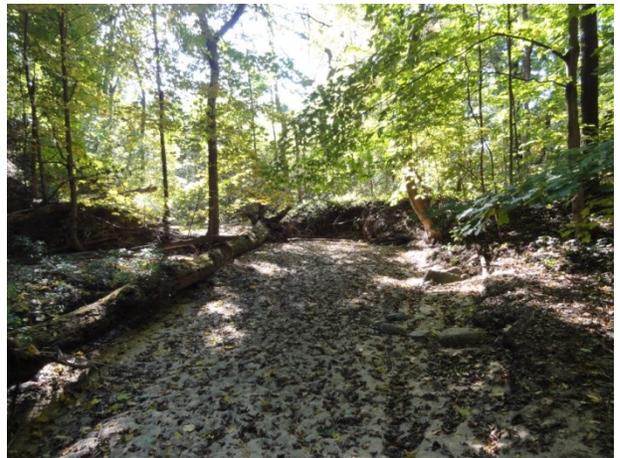
Potential stable sections of the stream were observed that included low bank heights (see photos FP 434, FP 447 and FP 453). The channel through the golf course was notable for its narrow geometry (photos FP 471, FP 474 and FP 476). This may be attributable to the availability of sunlight allowing good cover plants such as grass to grow on the banks.

FP447-Old and New Channels

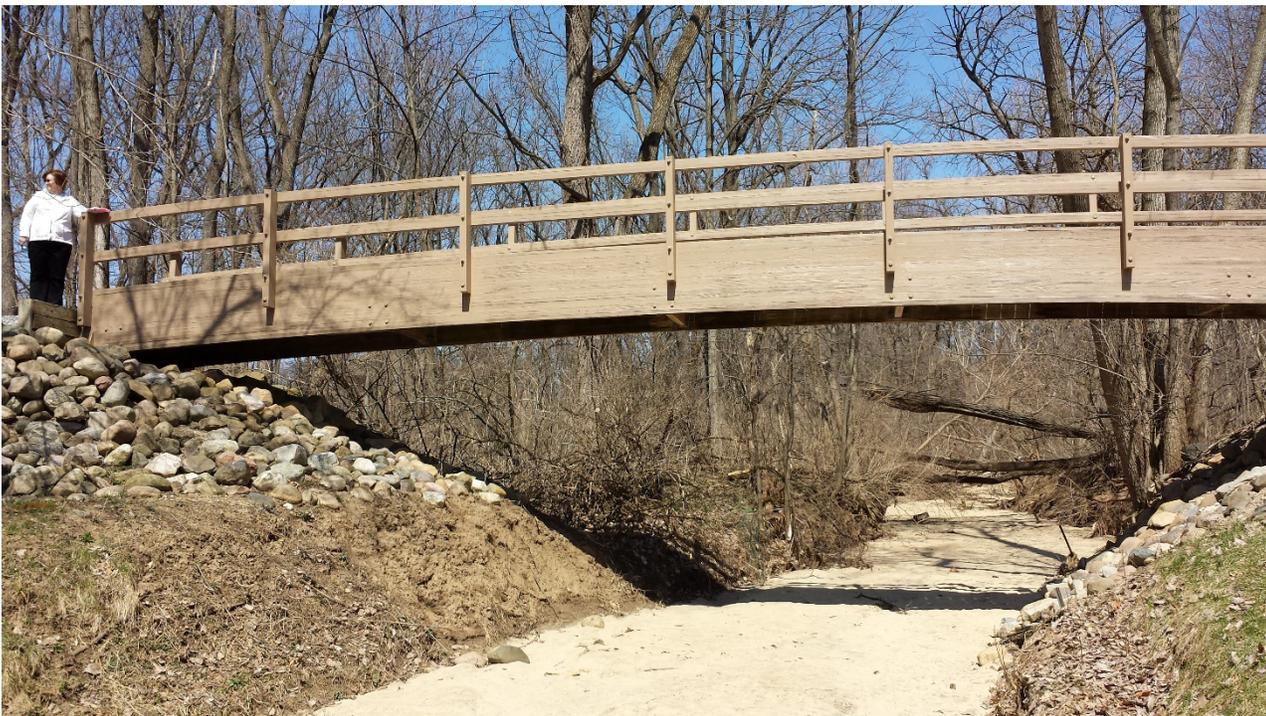
The **stream bed** only 5 years ago was at about where the rocks start on the left! Lots of sand & silt washed away.

We suggest that DLZ & City consider the installation of stream bed gabions to restore the stream bed depth. The picture below is just last spring (2015) and one can see the loss bed loss in just 2015!!

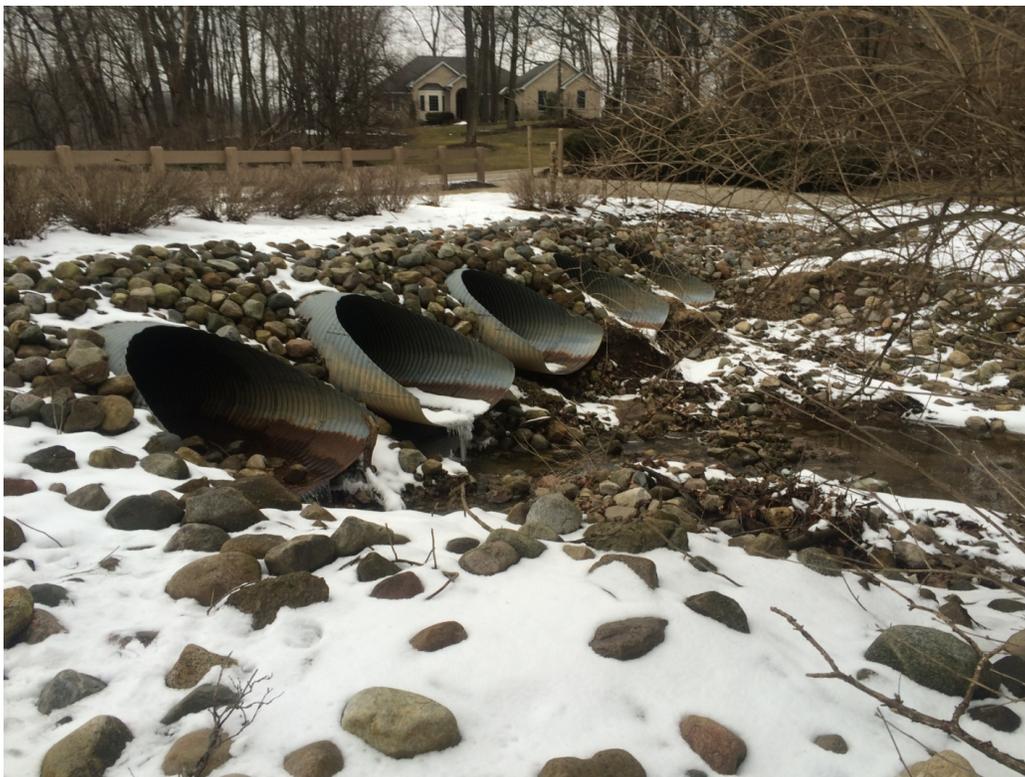
Although there was a picture of the culverts under William Drive in the DLZ report, the report should provide more specific recommendations to restore and stabilize the stream bed. It should be noted that this is the downstream view of this culvert. Note, these **boulders** at the exit of the pipes **were above the pipe lips** only a few years back!

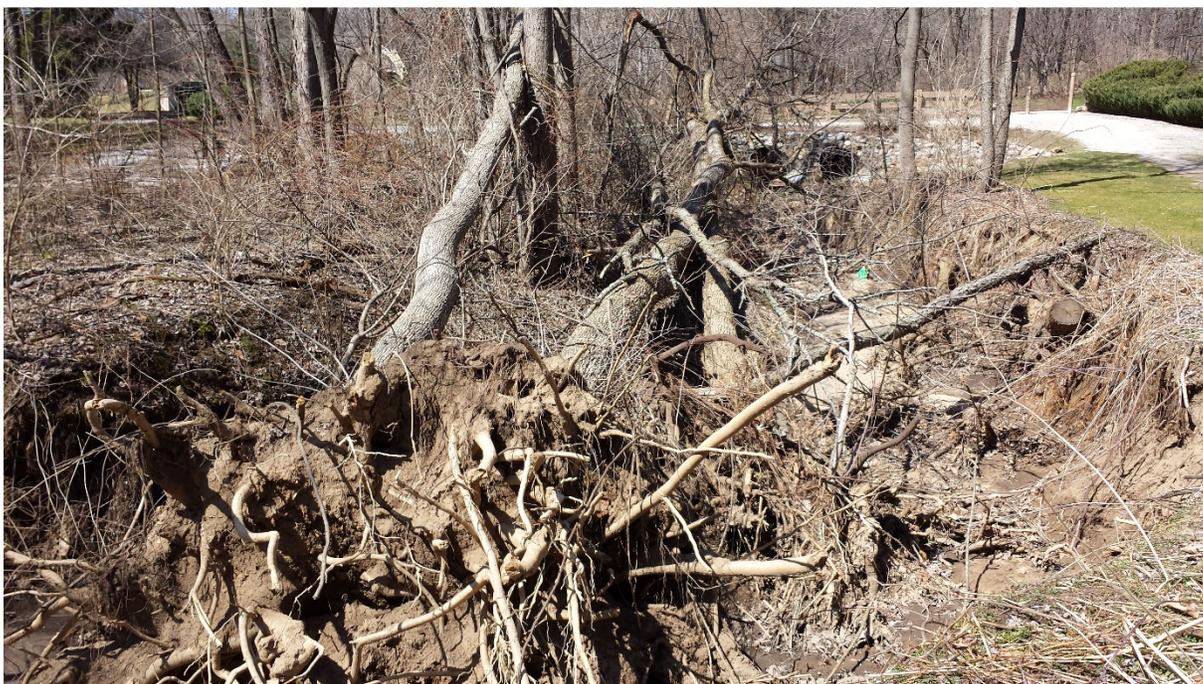
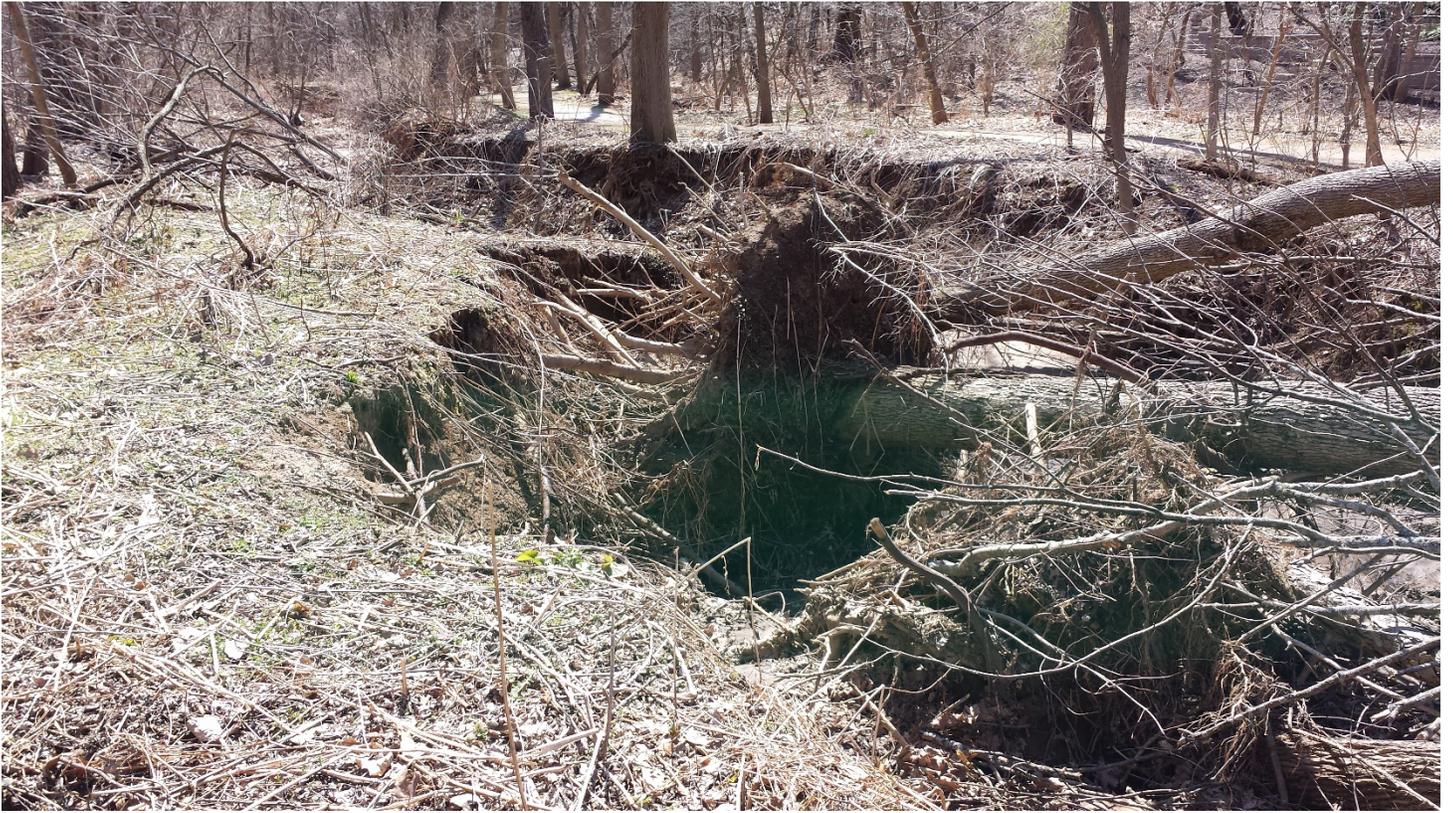
Further downstream of this picture, the MMPOA **lost 7 large-diameter mature trees in one weekend** rain fall last spring (2015) due to the intense scouring of banks and under cutting of the root systems of large trees that previously were the very reason for bank integrity. With these types of catastrophic losses of trees and the very “fabric” stabilizing the banks, it is nearly impossible to re-create a similarly stable bank again.

These tree/bank losses more than **doubled the width of Beauty Creek in this section in one day!**

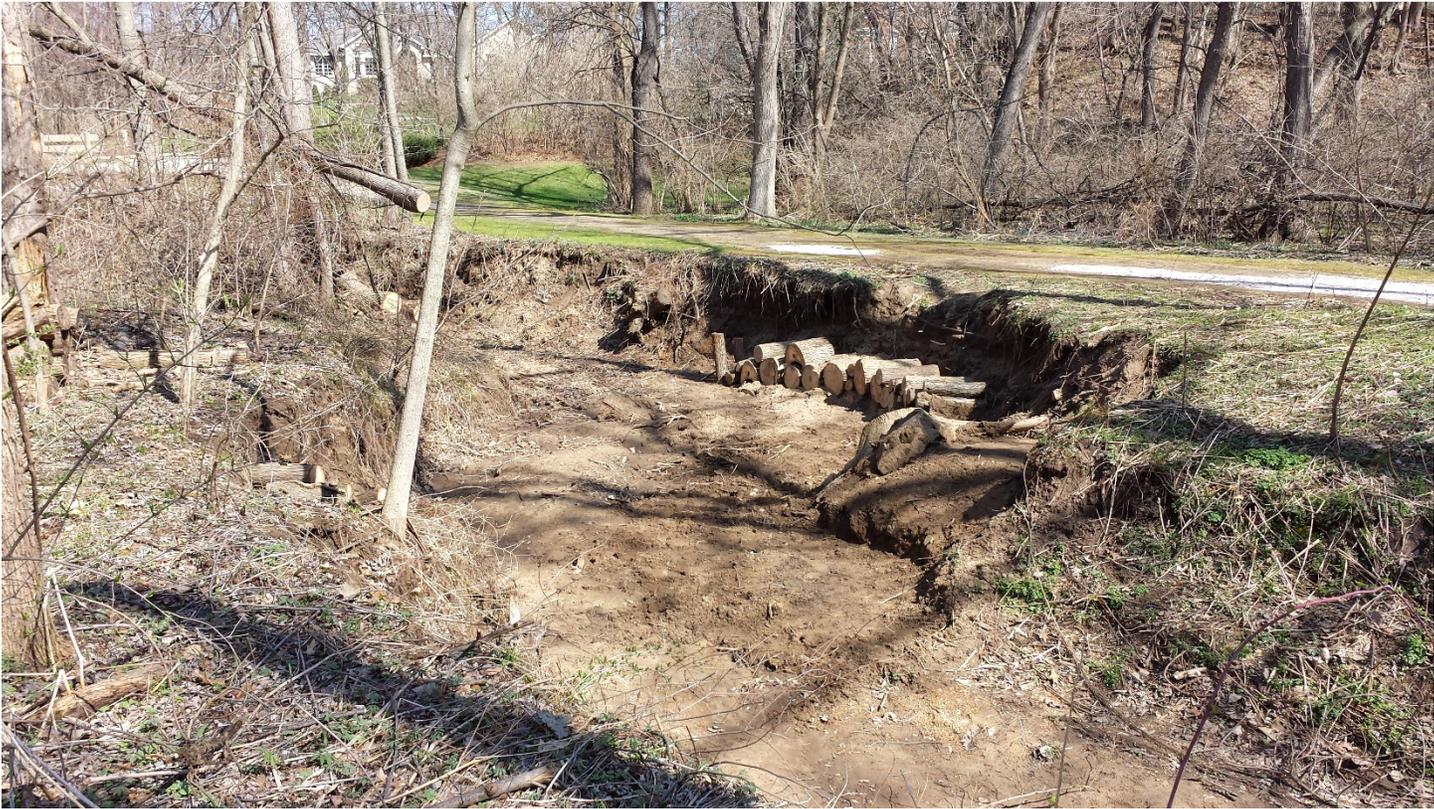
On the upstream side, as various obstructions have collected in front of the 5 major drain pipes, an island of silt & debris has formed a large blockage for most of the inlets to the drain pipes. This phenomenon somewhat mirrors the Hampstead Court situation where **only 20-25% of the drainage design/system is still operational**.

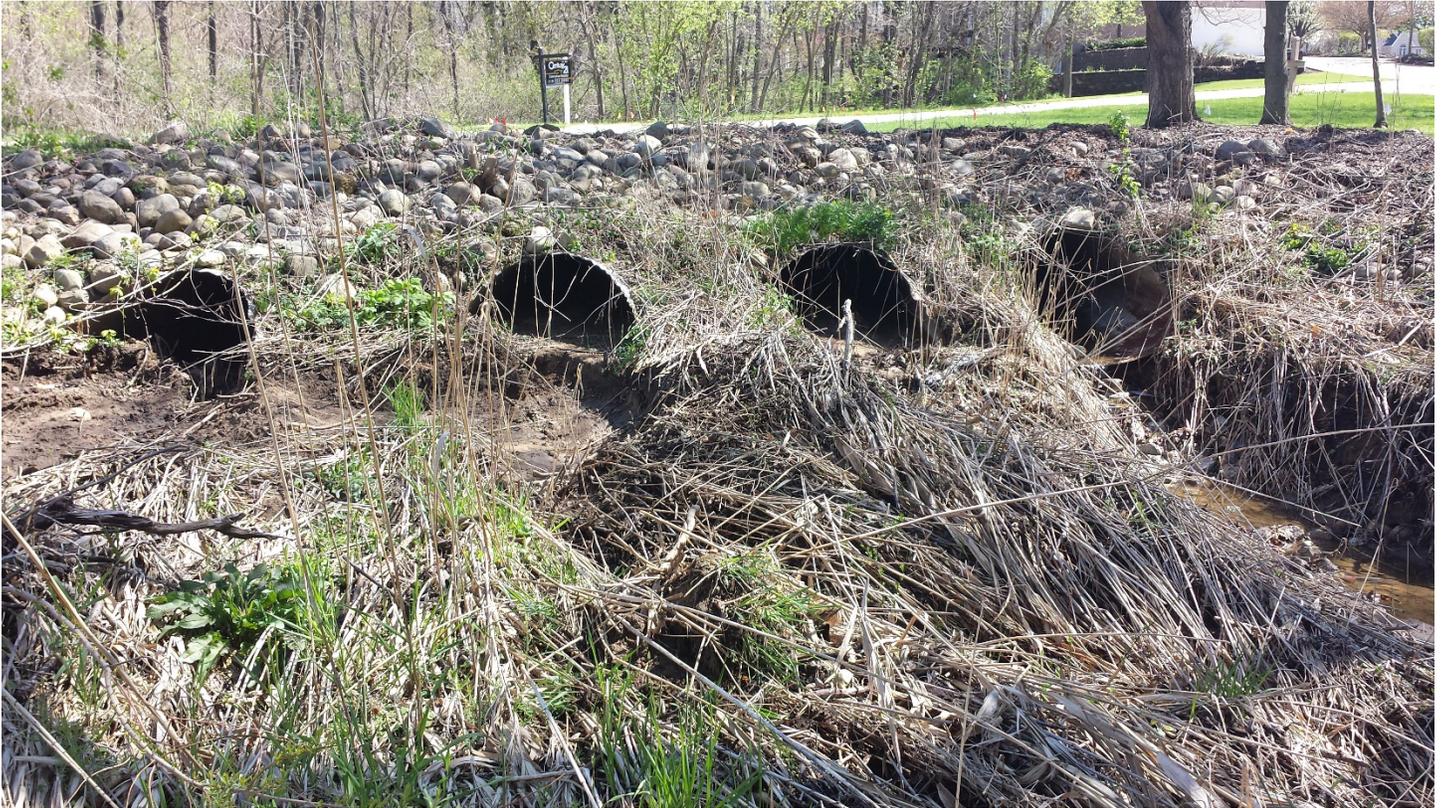
Note that the far right (southernmost) upstream drain pipe receives the vast majority of the flow and then on the downstream side that intense flow from a single point caused the bank damage and tree loss just shown in the above pictures. **William Drive needs fixed as well, but it was not even given mention by DLZ or the City!**
