Beauty Creek Watershed Study April, 2016

City of Valparaiso, Porter County, Indiana

DLZ Job No. 1564 -1276
April, 2016

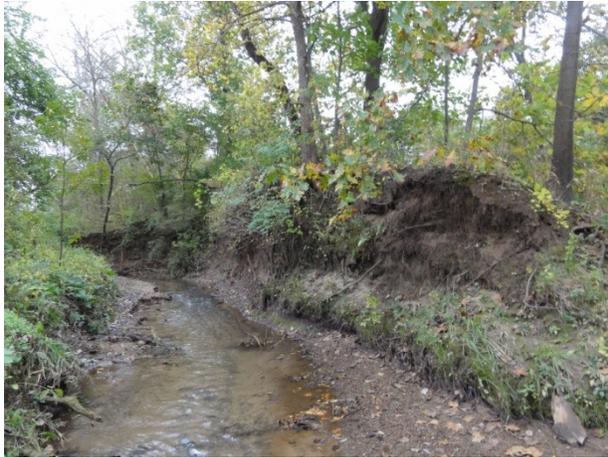
Starting at the confluence with Salt Creek, bank erosion on Beauty Creek is occurring. Picture BC 2 shows the steep outer bank of the creek bend before entering Salt Creek. This bend turns nearly 90 degrees and is at least 8 to 10 feet high. Continuing upstream, log jams were observed as shown in pictures BC 4, BC 13, and BC 31. The stream continues to be incised and deep. The stream bed appears to be primarily sand, possibly deposited from upstream. The bank material varies from clay (picture BC 10) to peat (picture BC 32).

BC2 -Eroded Bank

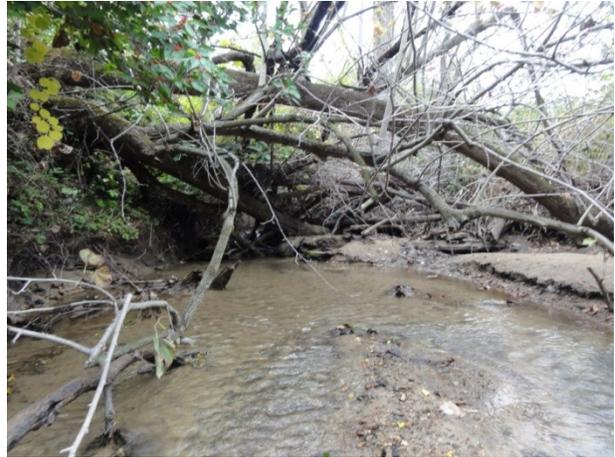
BC4-Log Jam

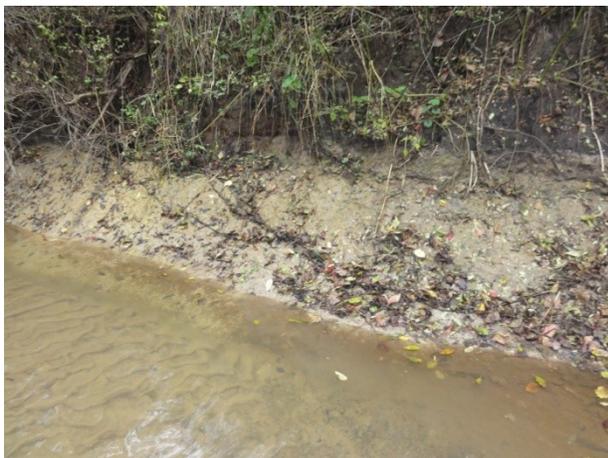
BC10-Clay Bank

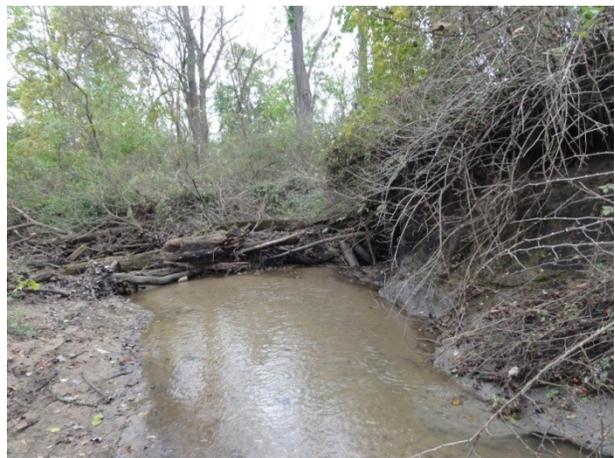
BC13-Log Jam

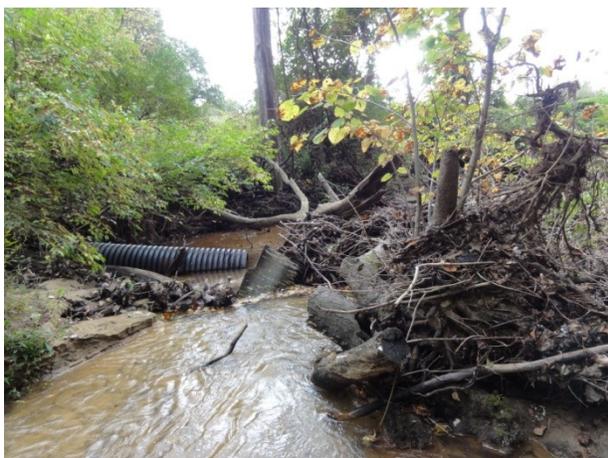
BC31-Log Jam

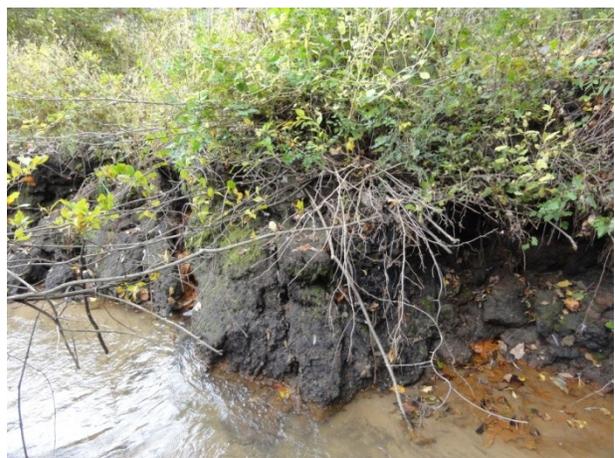
BC32-Peat Along Bank

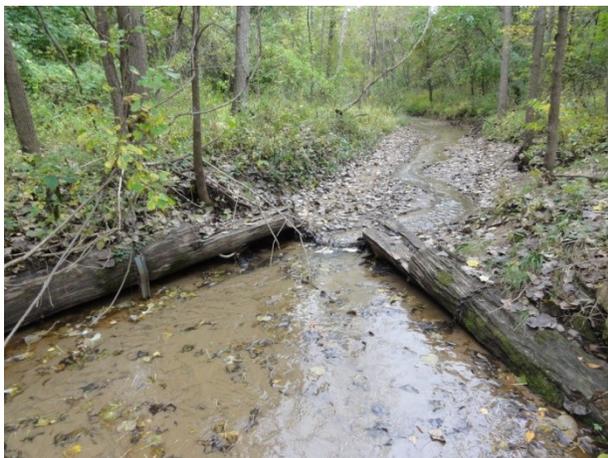
Evidence of other stabilizing practices was observed, including what appeared to have been a Gabion dam and a wooden cross vane structure (photos BC 49 and BC 56). A cross-vane structure forms a "V" in the channel with a wide bottom in the "V" approximately the width of the channel. Both structures appeared to have degraded with the Gabion dam having failed such that the stream has migrated around the dam toward the north bank.

BC56-Man Made Vane

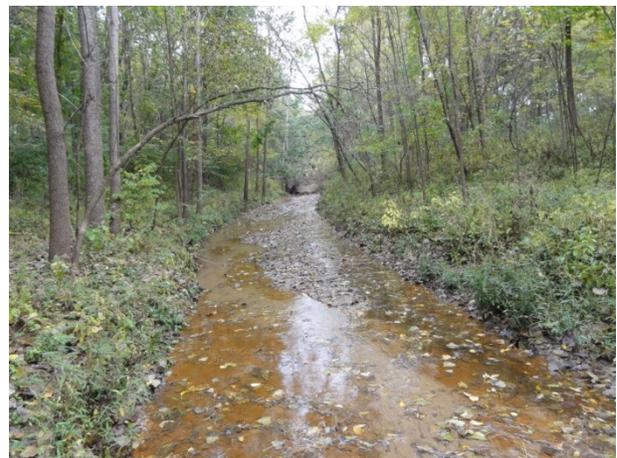
BC58-Netting on Banks

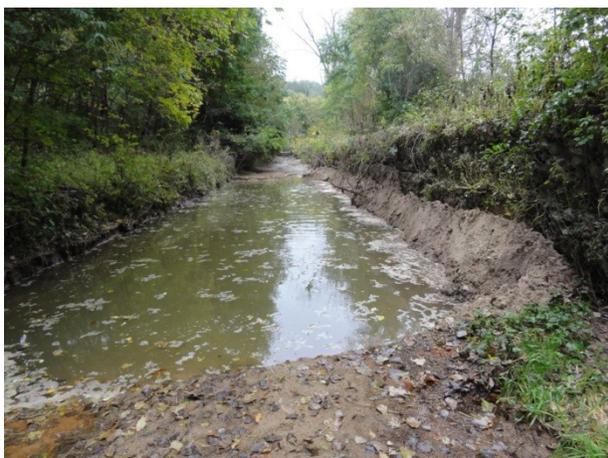
Lastly, the confined stream with Gabion step dams and sediment trap immediately south of Harrison Boulevard was observed (see photos BC 63 and BC 65). All structures appeared to be in good condition and the sediment trap appeared to have been cleaned recently.

BC63-Dug Out-Water Deep

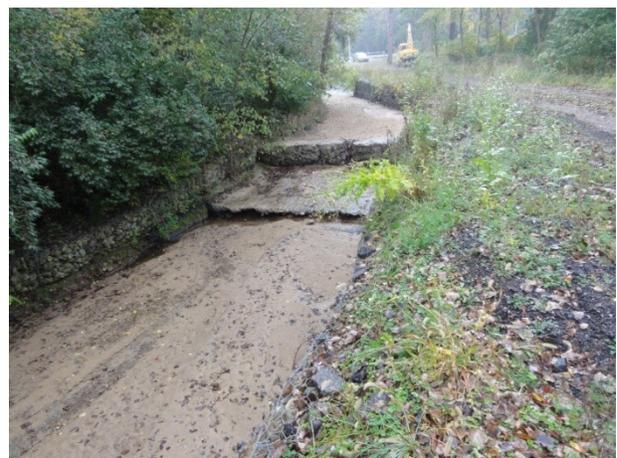
BC65-North of Shot BC63

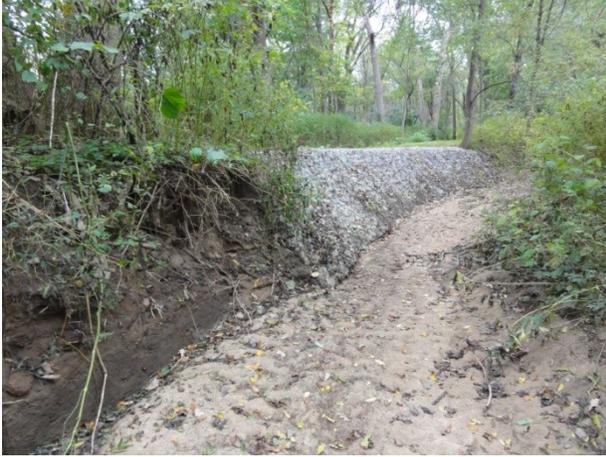
The upper branch of Beauty Creek displayed similar erosion problems as observed in the lower branch. Blockages and bend erosion were frequently observed. Examples of the bend erosion can be seen in photos BC 121, BC 143, BC 210 and BC 222. Examples of bend blockages including log jams were noted throughout the stream course covered by this study (see photos BC 139, BC 158, BC 165 through 179, and BC 236). Besides diverting flow into the bank, debris can also create scour holes by creating a hydraulic jump (see photo BC 189 and BC 202).

BC121-Reno Mattress on West Bank

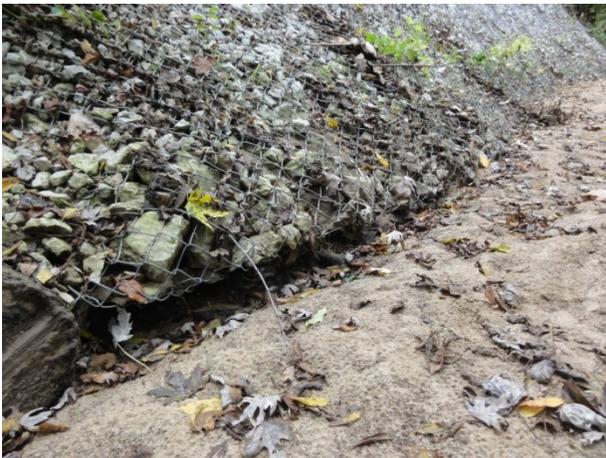
There was an area where the bank had been stabilized with Reno mattresses (see photo BC 123 and BC 125). The photos show while the bank covered by the mattresses may be more stable than adjoining banks areas, the stream bottom is being eroded as well as the upstream lower corner of one blanket. The streambed undercutting may eventually undercut the base of the blanket and lead to possible failure. In addition, the upstream unprotected bank is eroding which may also cut behind the mattress and lead to failure.

BC125-Reno Mattress Detail

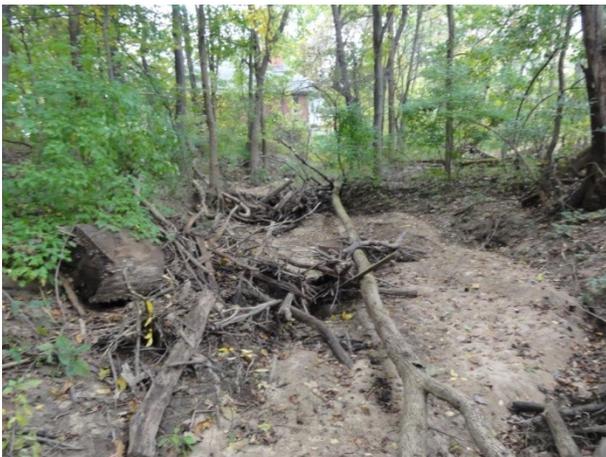
BC139-Tree Blockage And Erosion

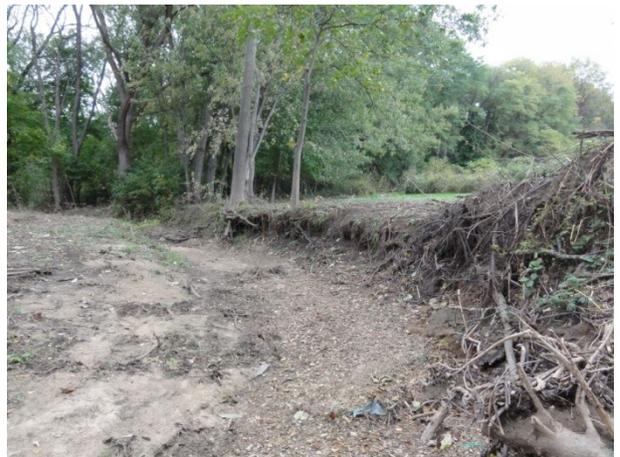
BC143-Dry Stream-Flat Area

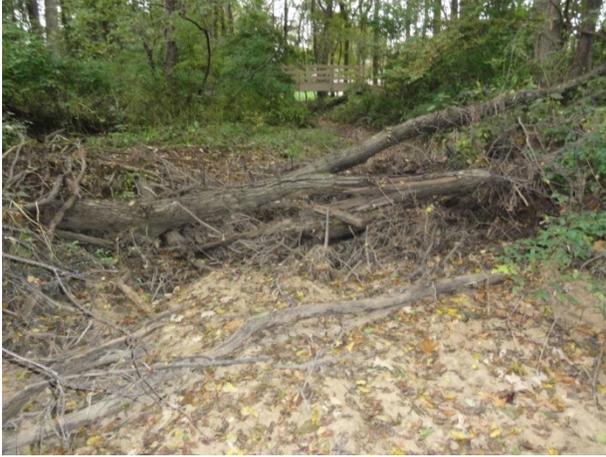
BC158-Tree Blockage

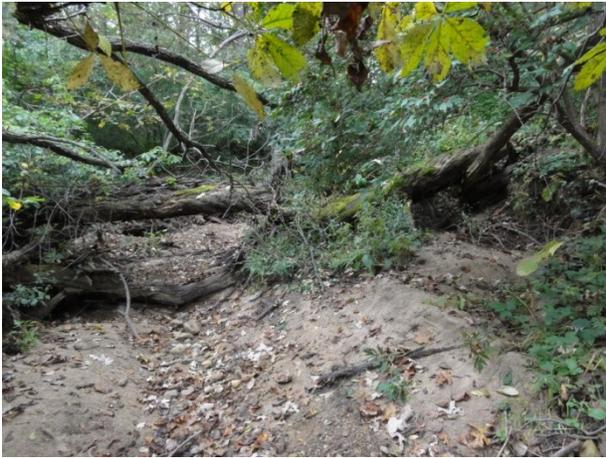
BC165-Tree Blockage And Erosion

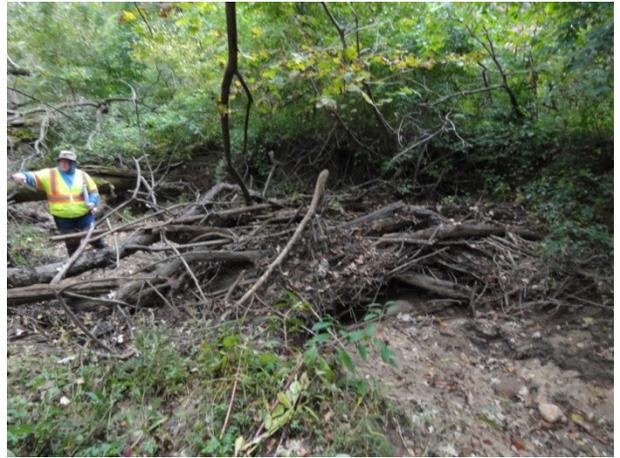
BC166-Tree Blockage And Erosion

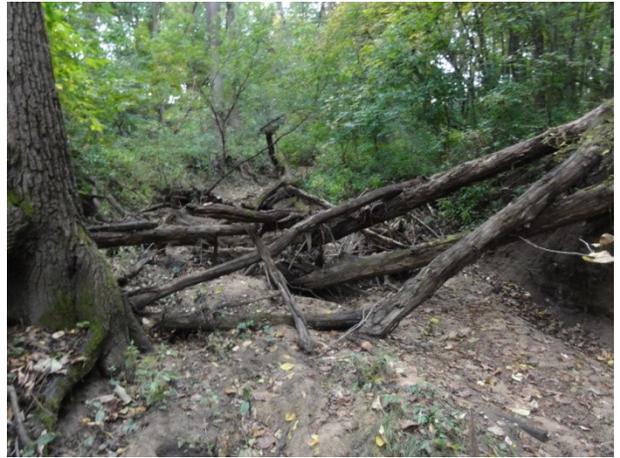
BC176-Looking North-Tree Blockage

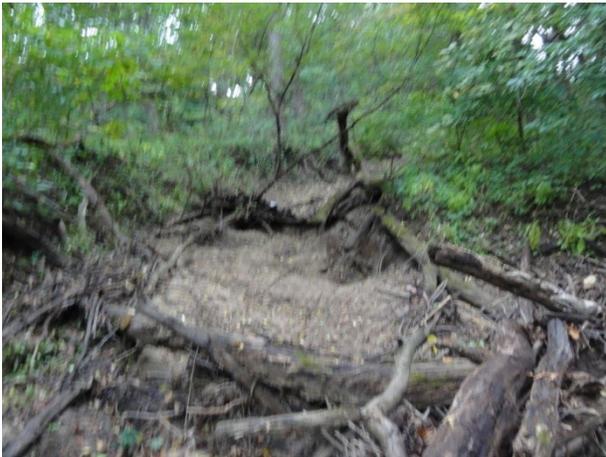
BC177-Looking North-Tree Blockage

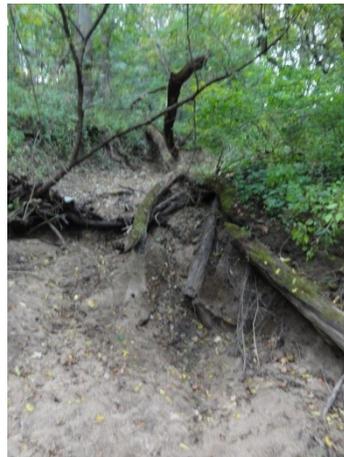
BC178-Looking North-Tree Blockage

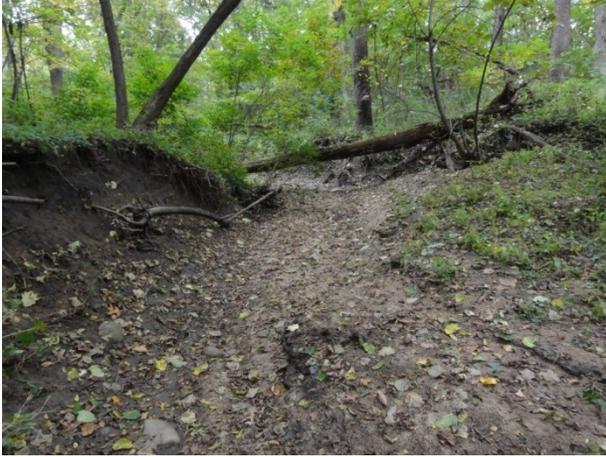
BC179-Looking North-Tree Blockage

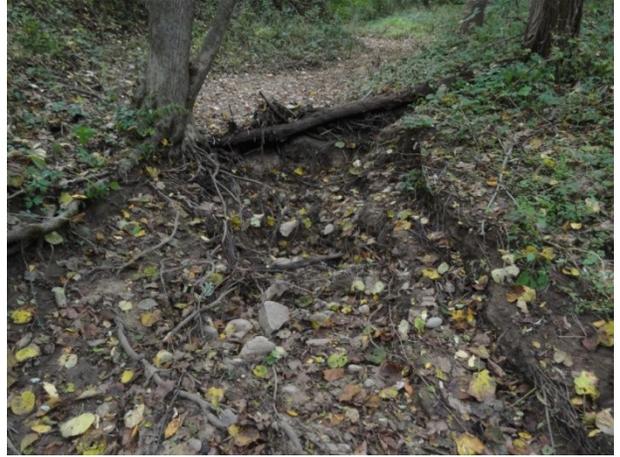
BC189-Erosion

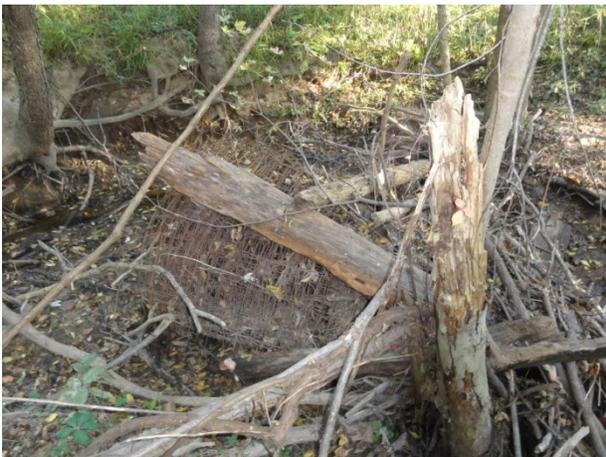
BC223-Wire Fence Roll

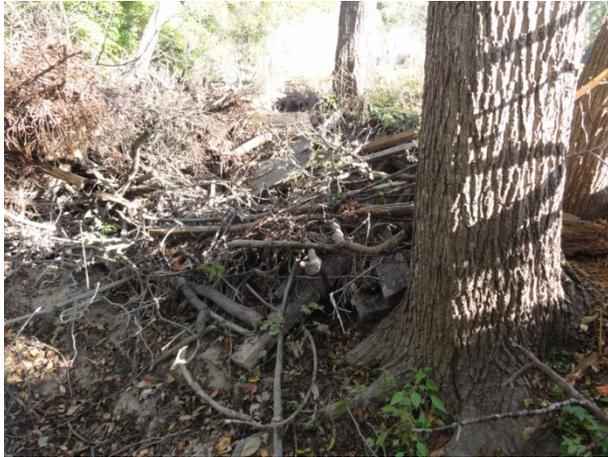
BC229-Tree Blockage with Scour Hole

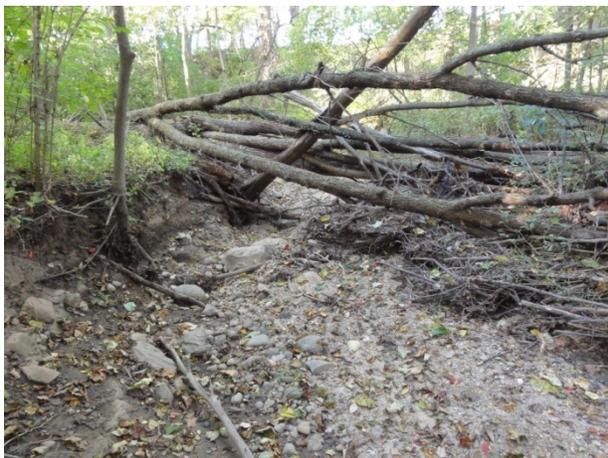
BC236-Looking South-Tree Blockage At Curve

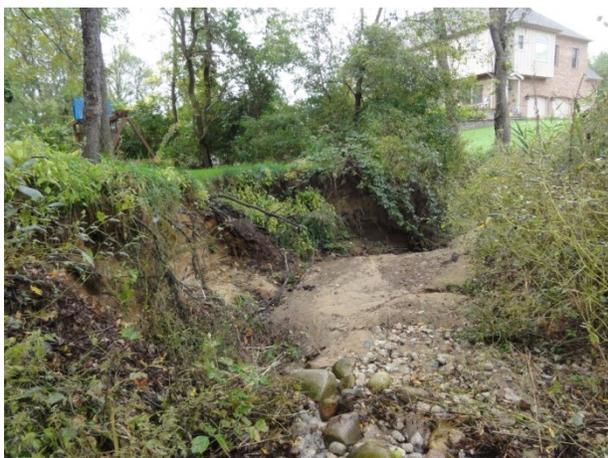
BC245-Looking North-Culvert Pipe

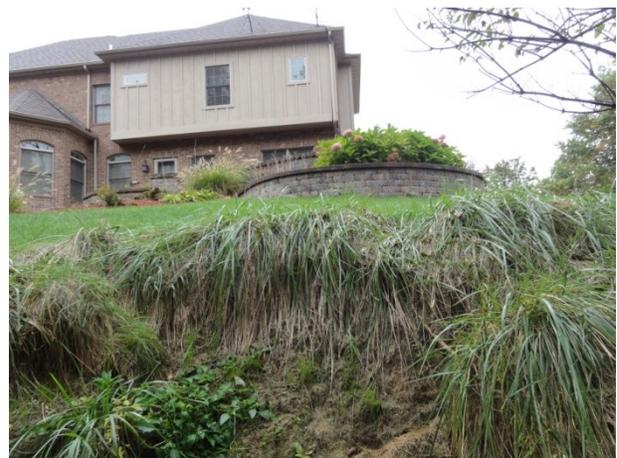
CW74-Hampstead Ct-Erosion-Steep Banks

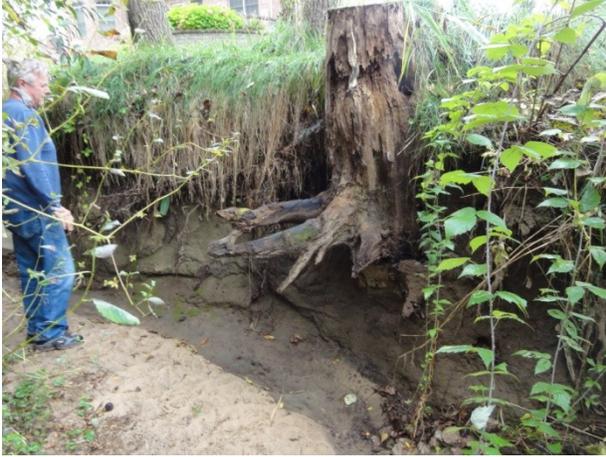
CW77-Steep Banks Near Western Home

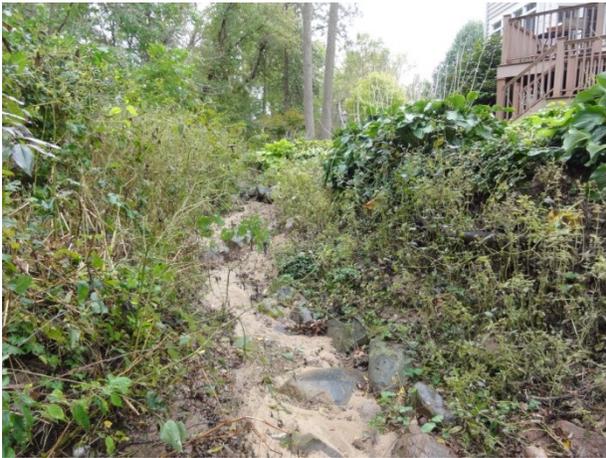
CW79-Grass Clippings

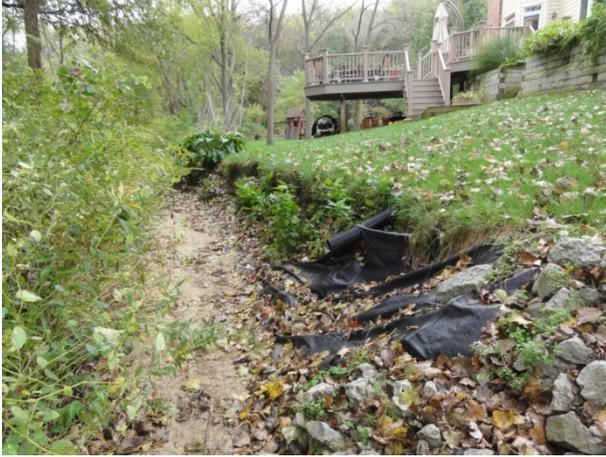
CW86-Erosion At Bend

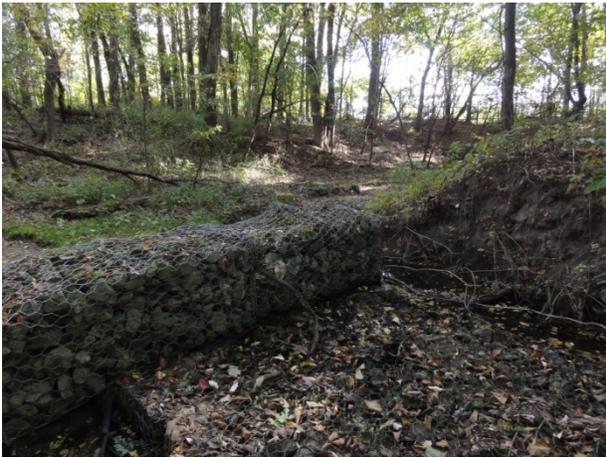
CW108-Looking SW

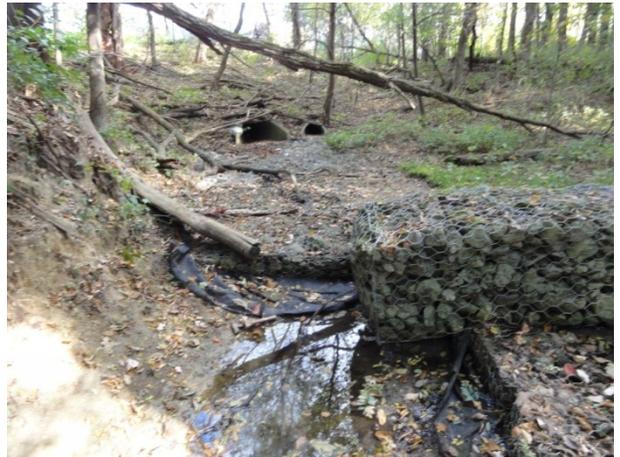
OW305-Gabion Near School-Down Stream

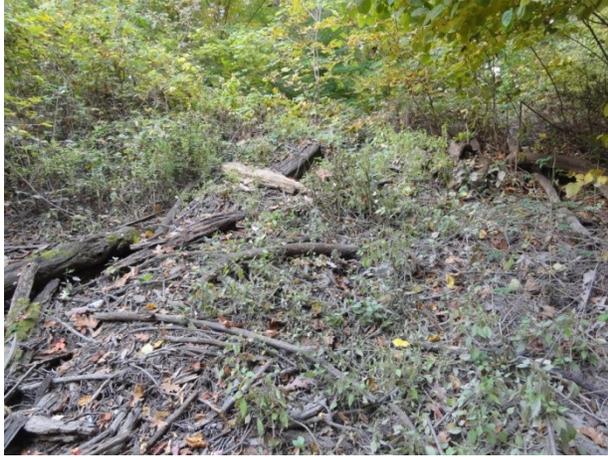
OW306-Looking North-Baseball Outfall

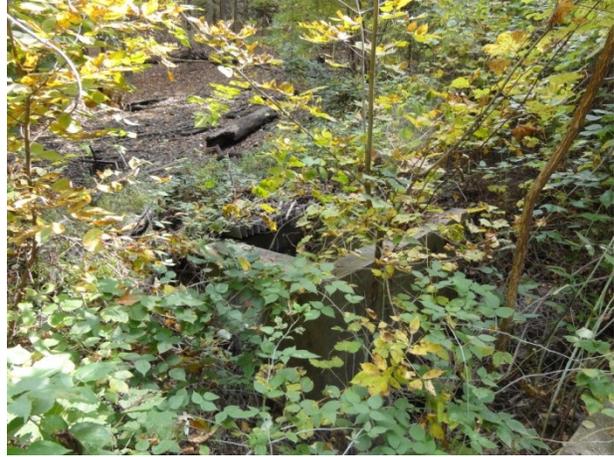
OW314-Culvert Entrance on the NE Side-
Blocked

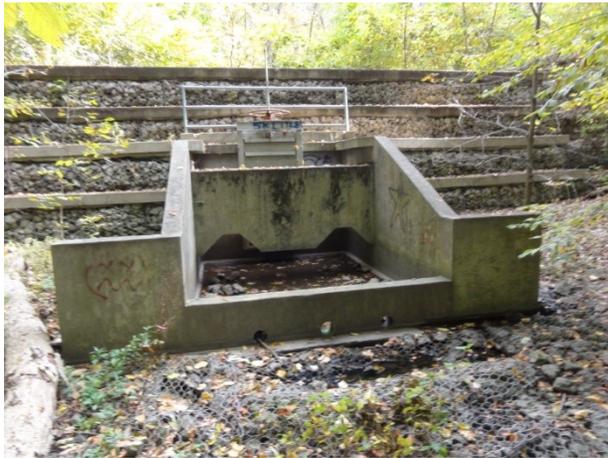
OW315A-Blocked NE Side of Culvert

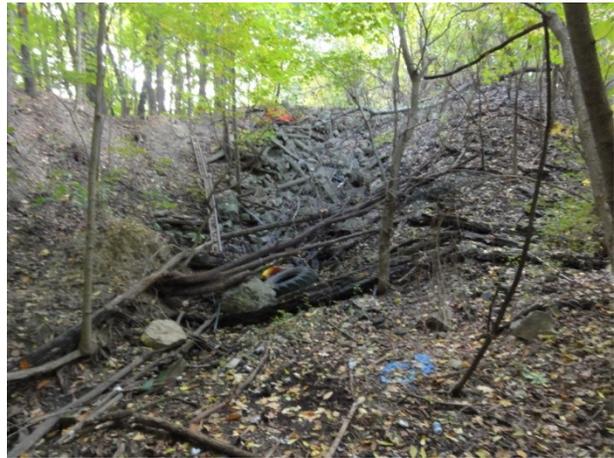
OW317- SW Side of Culvert

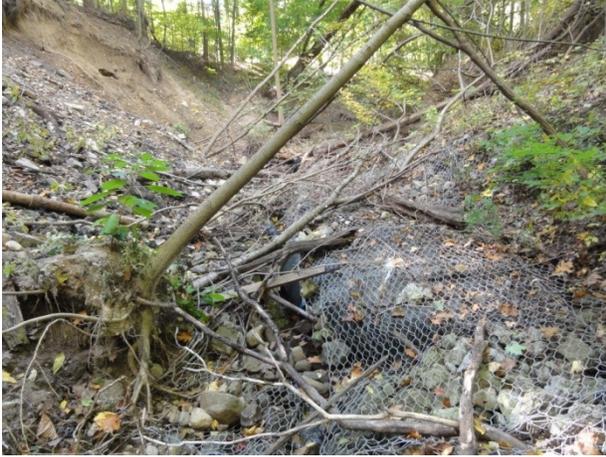
OW321- Trash and Debris Dumped

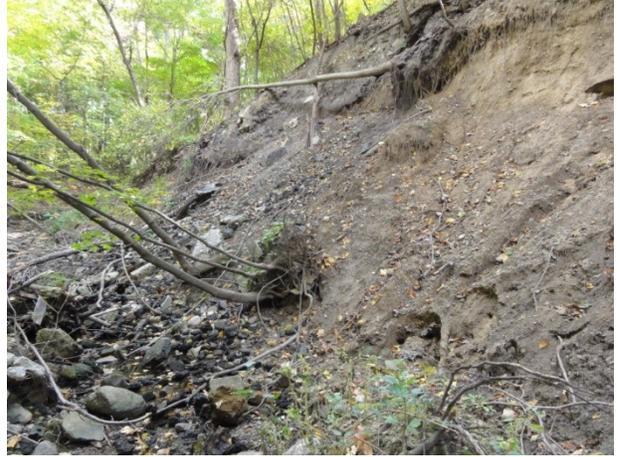
OW322-Blockage with Some Armouring

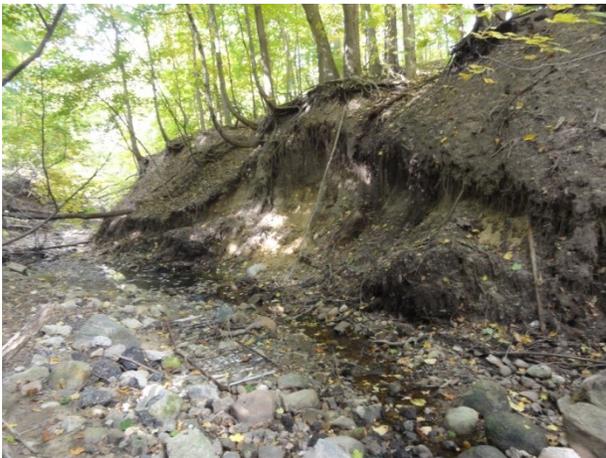
OW324-Erosion-Armouring End

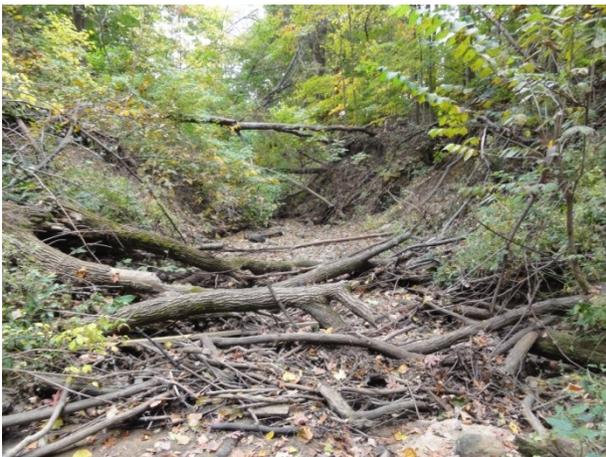
OW326-Erosion-Tree Undermined

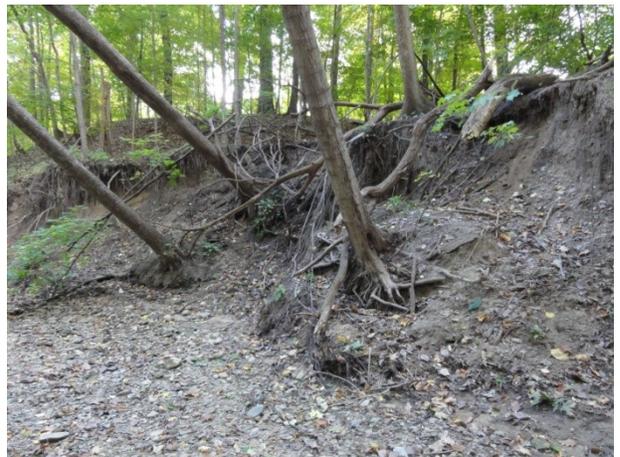
OW328-Erosion-Tree Blockage

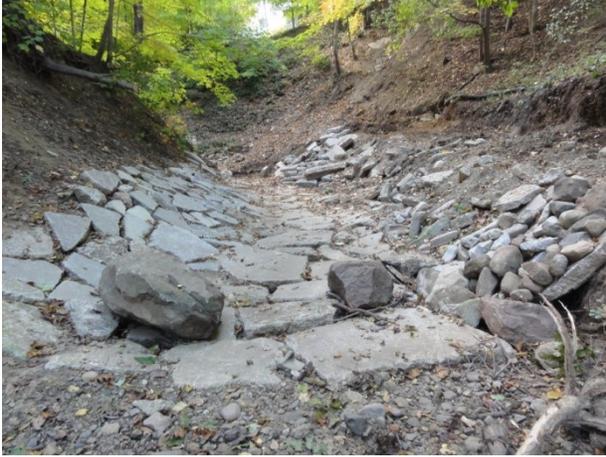
OW333-Bank Erosion-Trees Undermined

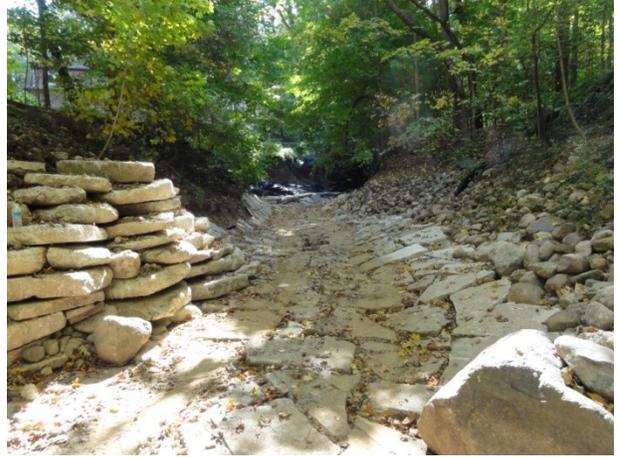
OW334-Large Stone -Erosion on Sides

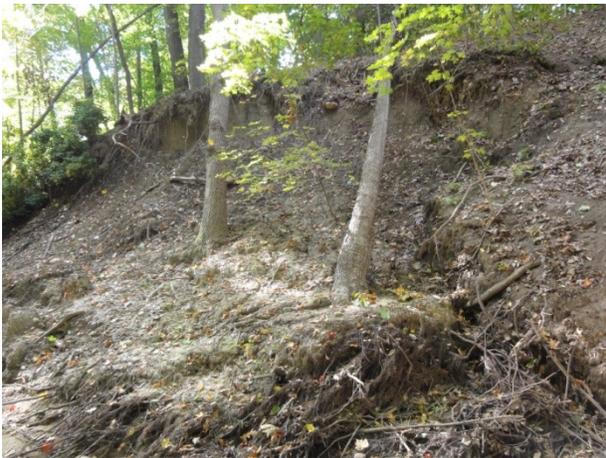
OW336-Large Stone and Fabric

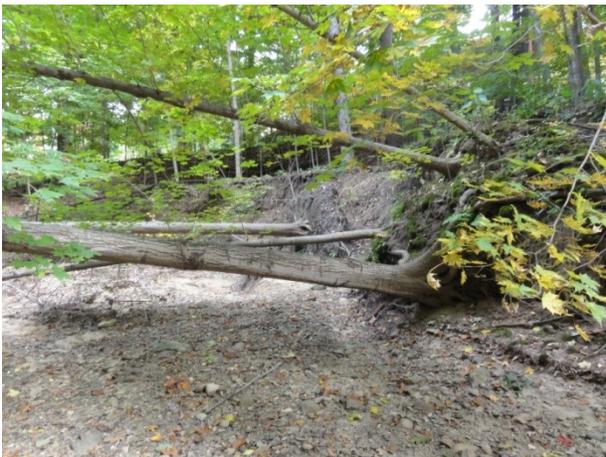
OW344-Downed Trees -Green Leaves

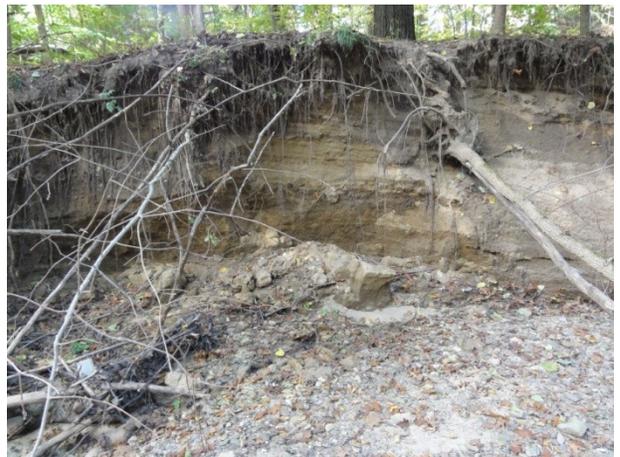
OW345- Downed Trees Near OW344

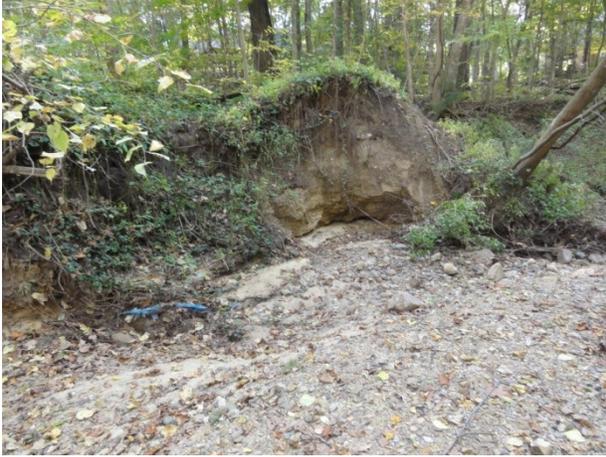
OW348-Bank Erosion

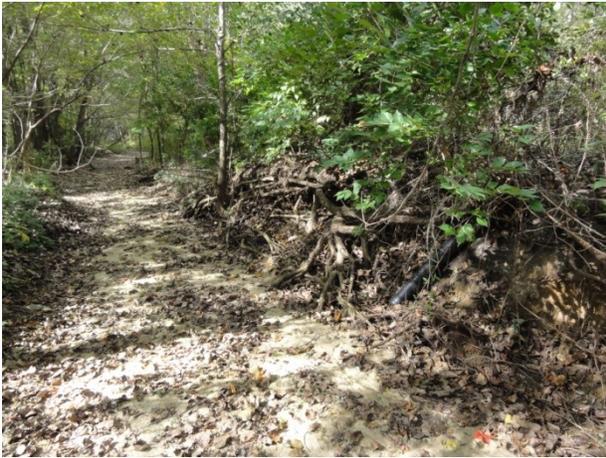
OW390- West Side of Old Oak Dr

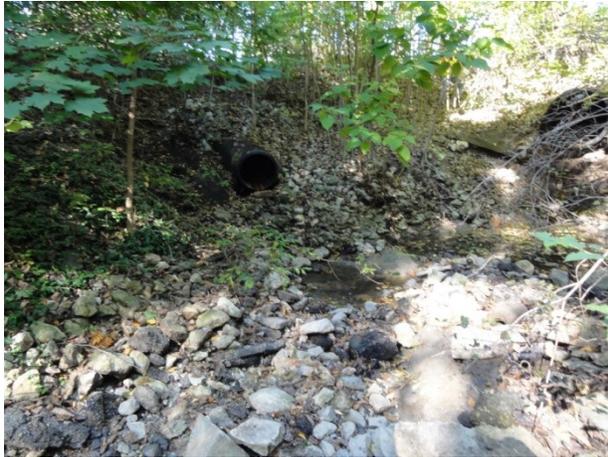
FP400-Two Outlets-36 Inch and 21 Inch

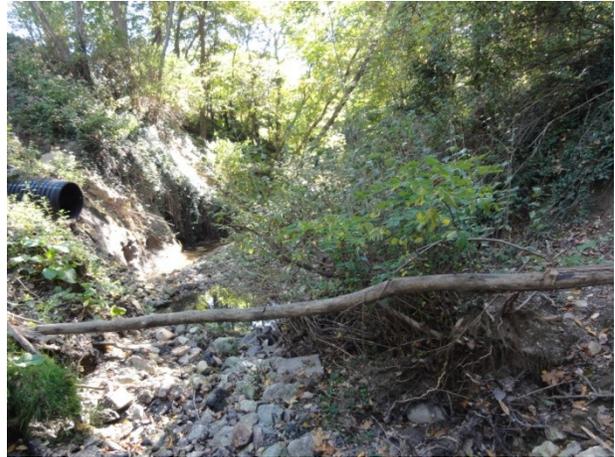
FP401-Other Culvert Pipe at FP400-Erosion

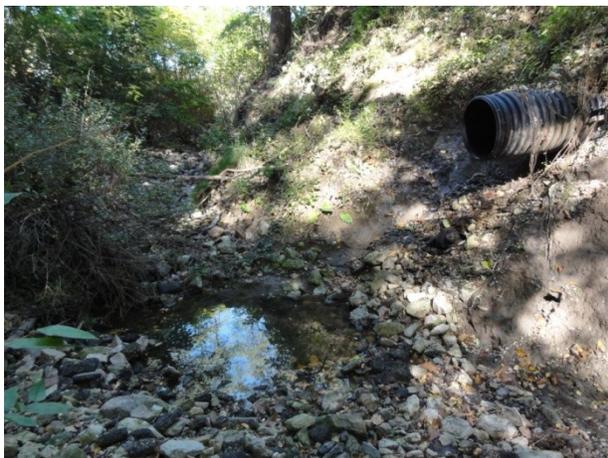
FP402-Drainage Pipe -Stones

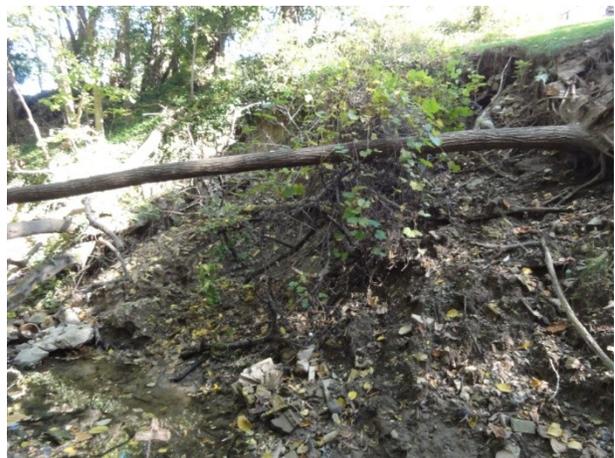
FP403-Same Pipe as in FP402

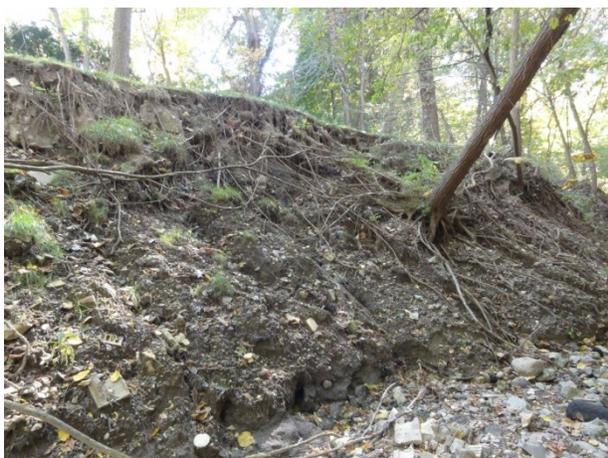
FP406-Tree Debris

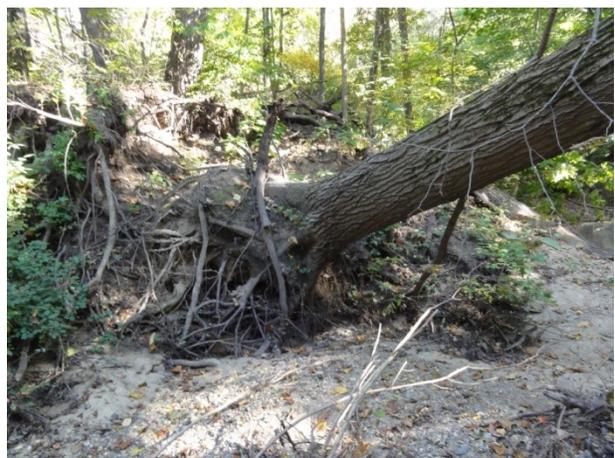
FP407-Erosion-Tree Undermined

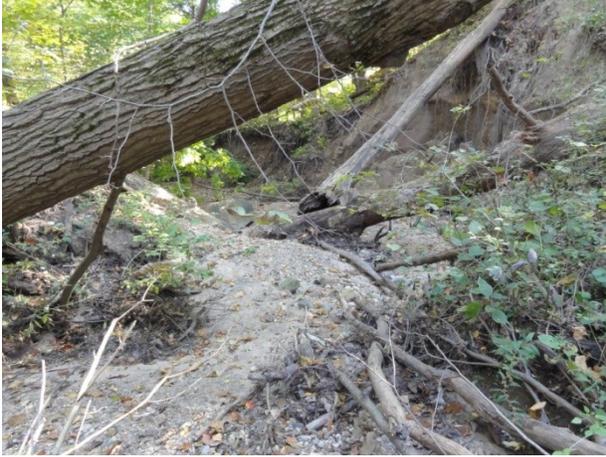
FP424-Erosion-Tree Blockage

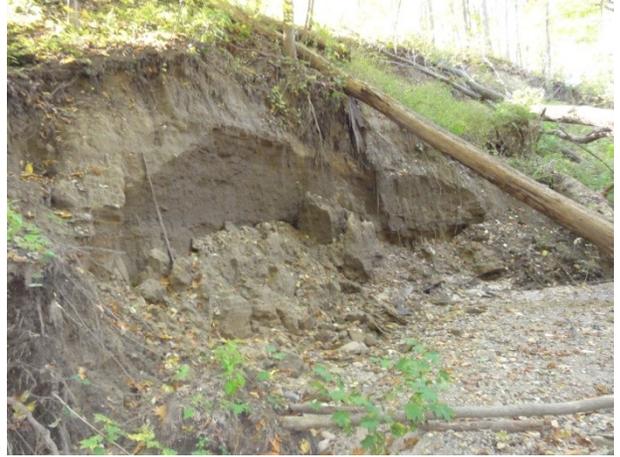
FP425-Tree Blockage-Same Location as FP424

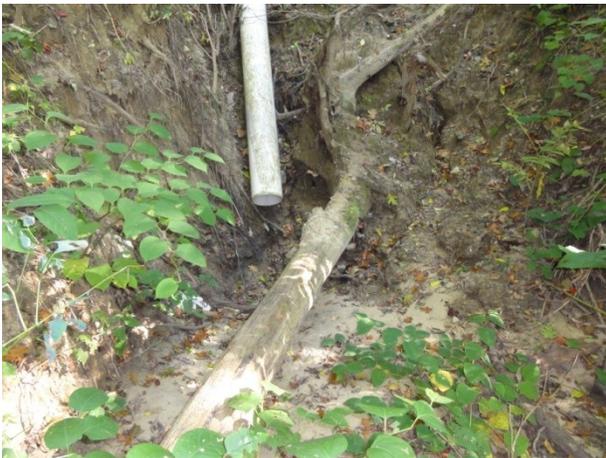
FP426-Bank Eroding-Sandy

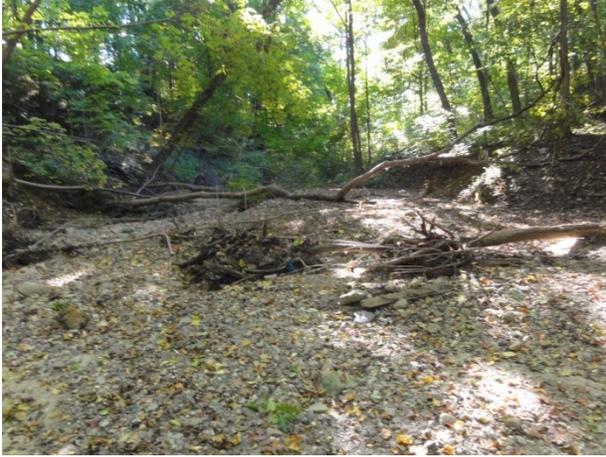
FP433-Erosion From Rear Yard Pipe-Same
FP432

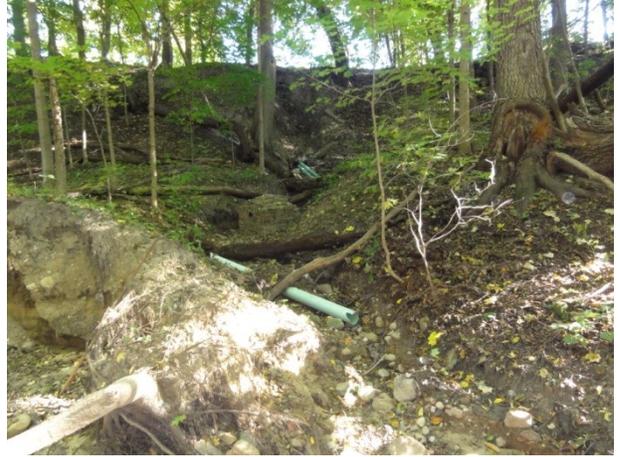
FP434-Sandy-Erosion-Wide Stream Bed

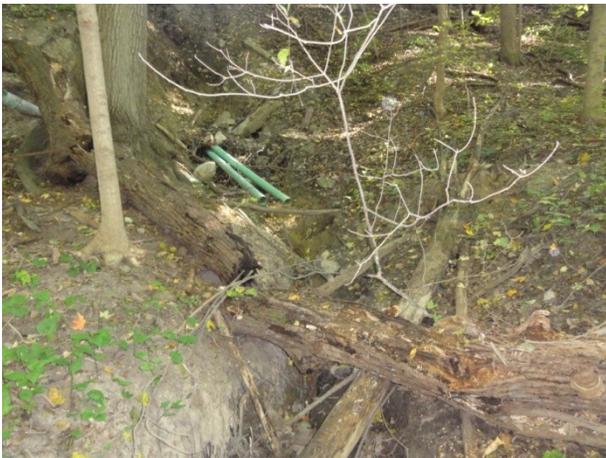
FP444-East Bank-Pipes

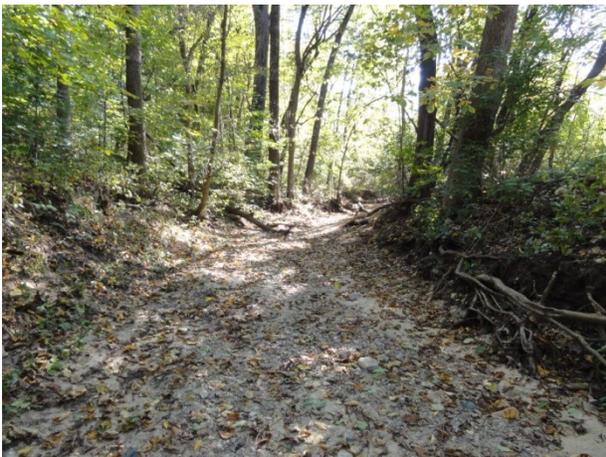
FP447-Old and New Channels

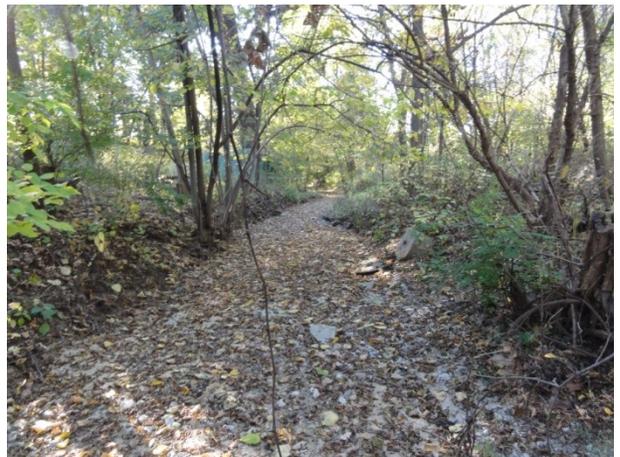
FP453-Erosion-Sandy-15' Wide

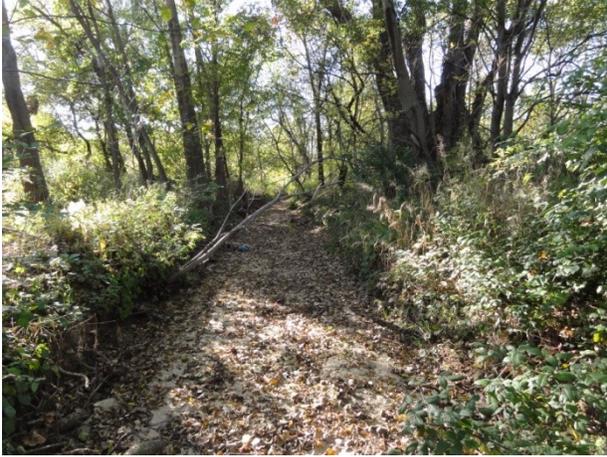
FP474-Looking West-Sandy Erosion

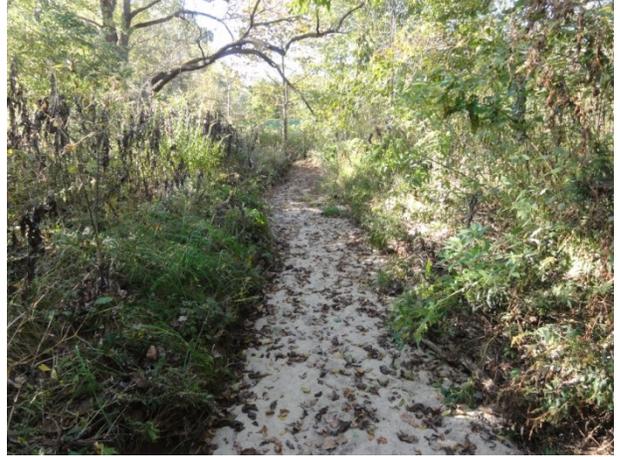
FP476-Looking NW-Sandy

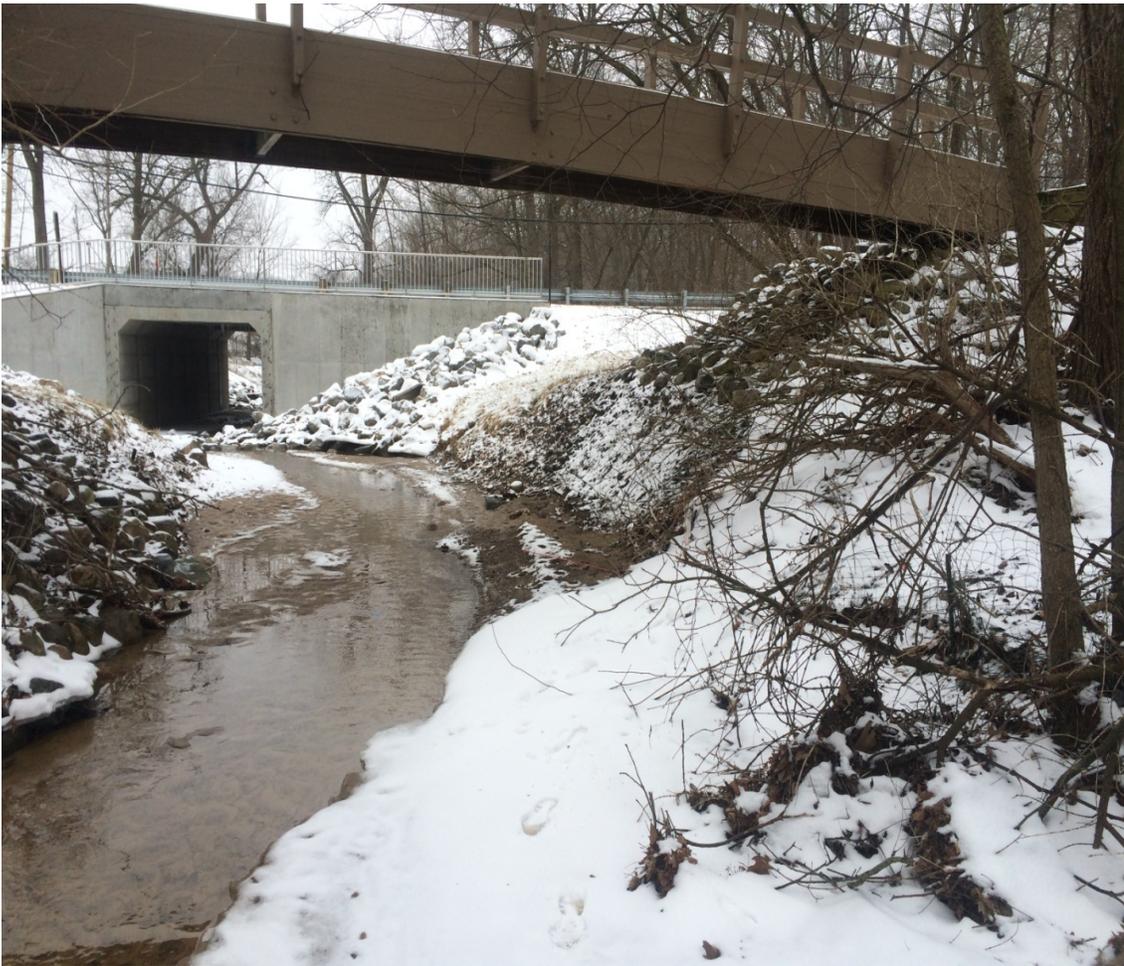
The DLZ report fails to identify other problems. First is upstream of Harrison Blvd. where the City of Valparaiso installed a new drainage duct under Harrison Blvd. after washout of the previous culverts. It appears that the City constructed the new drainage duct approximately 4 ft. lower than the previous culvert invert elevation and has impacted the stream bed elevation at the Manchester Meadows footbridge approximately 50 ft upstream. As can be observed from the photo below, the right bank under the bridge is at a steep slope and there are no protective boulders present. It appears that these boulders have washed or moved downstream to the Harrison street road bridge.

We suggest that DLZ & City consider the installation of stream bed gabions to restore the stream bed depth. The picture below is just last spring (2015) and one can see the loss bed loss in just 2015!!
